Fort George G. Meade

Former Pesticide Shop

Restoration Advisory Board Meeting January 16, 2014

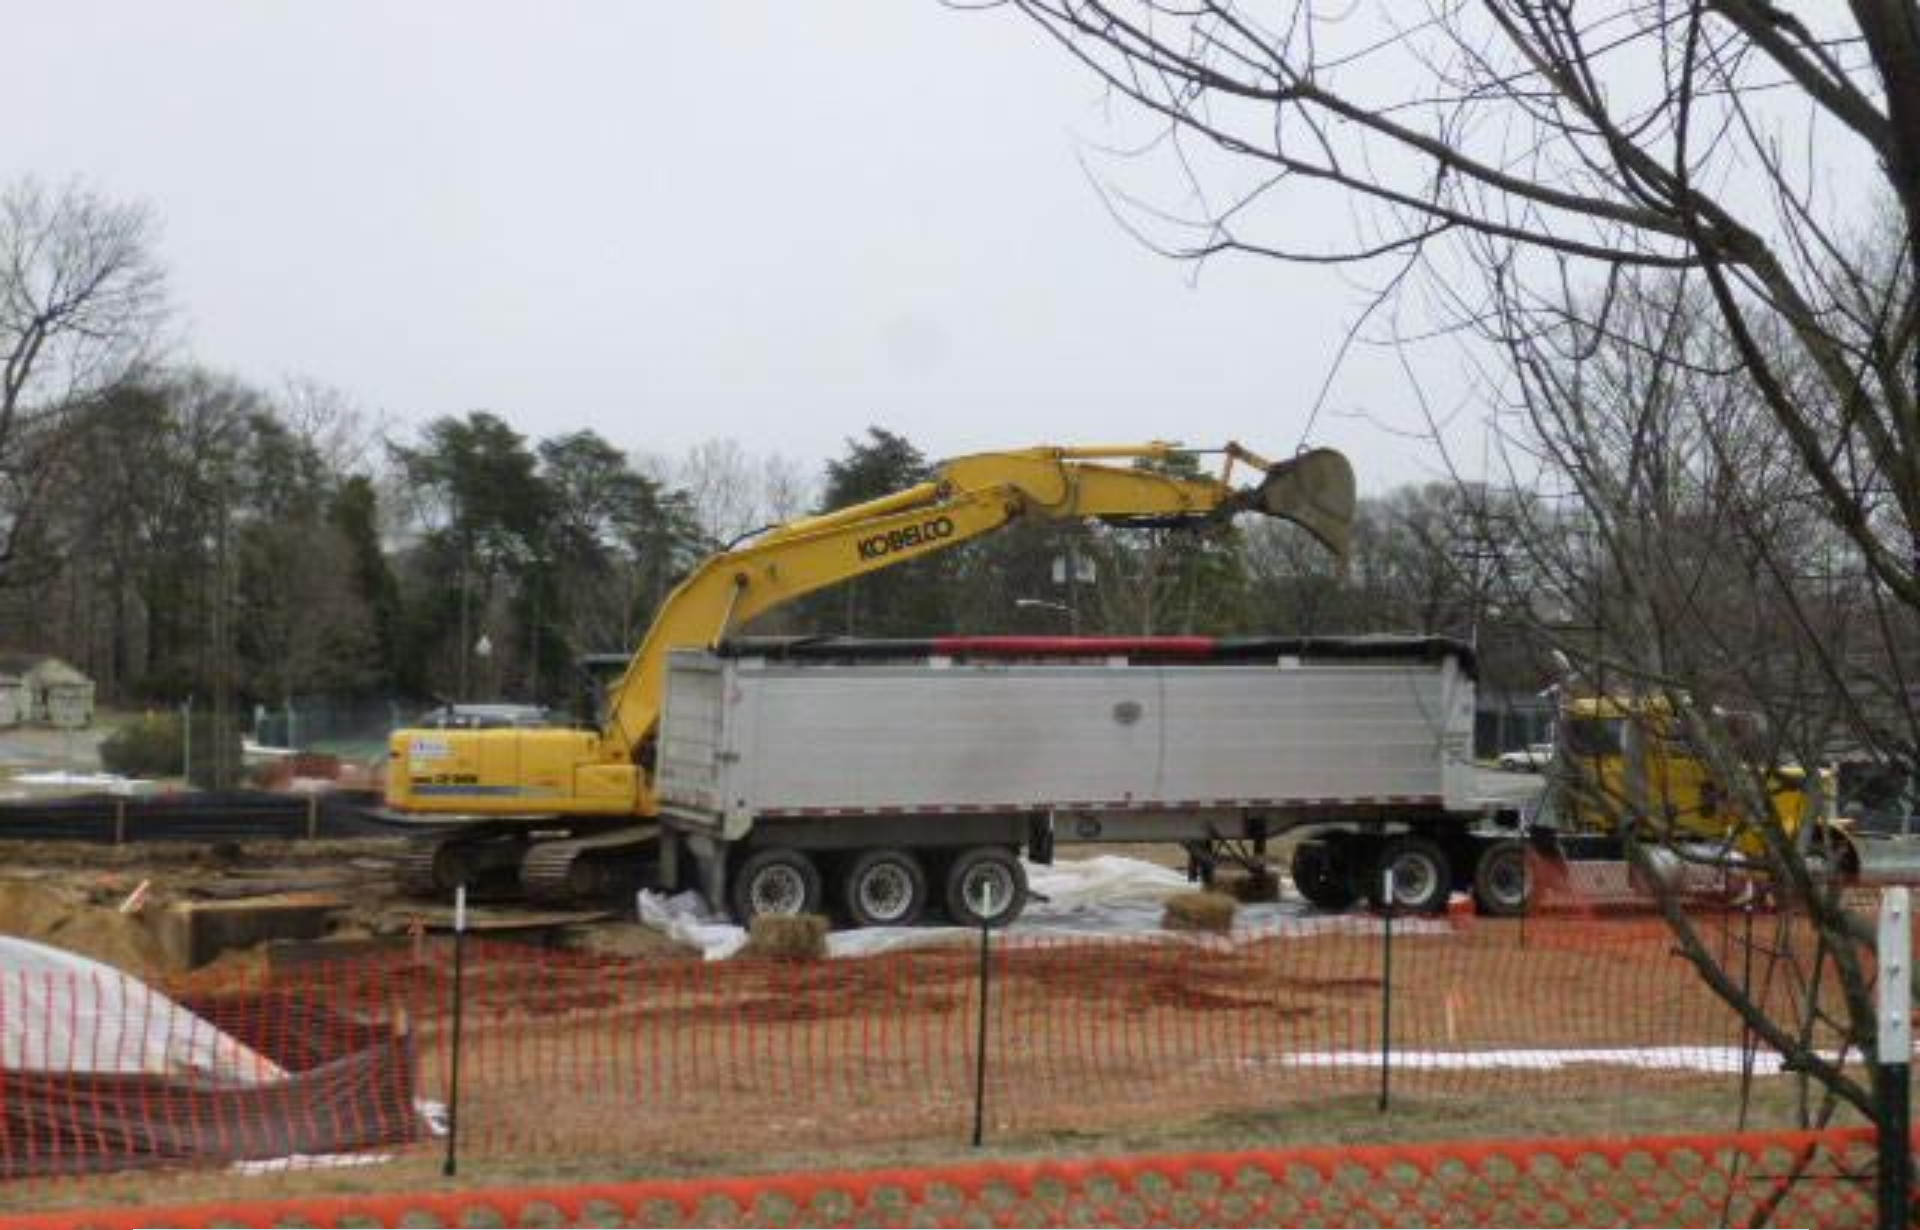
(Facing East) Loading and Site Control

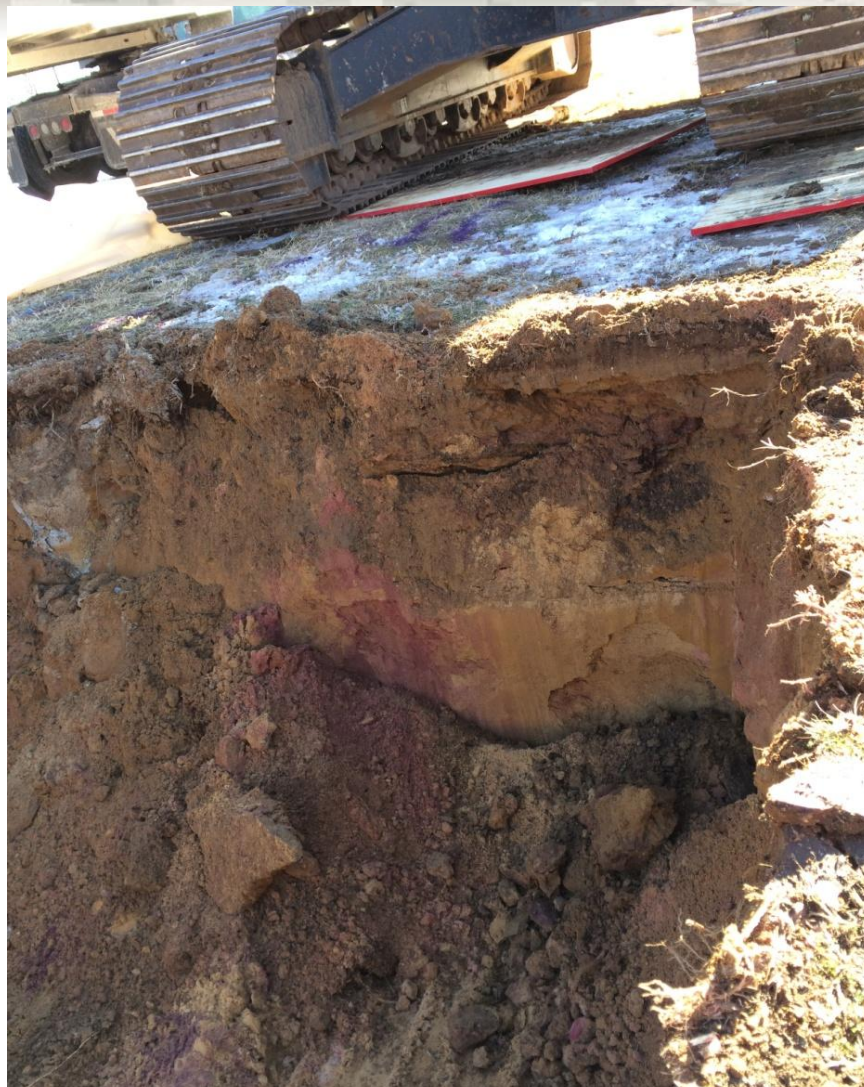
(Facing South): Purple Staining in Soil Grid C1

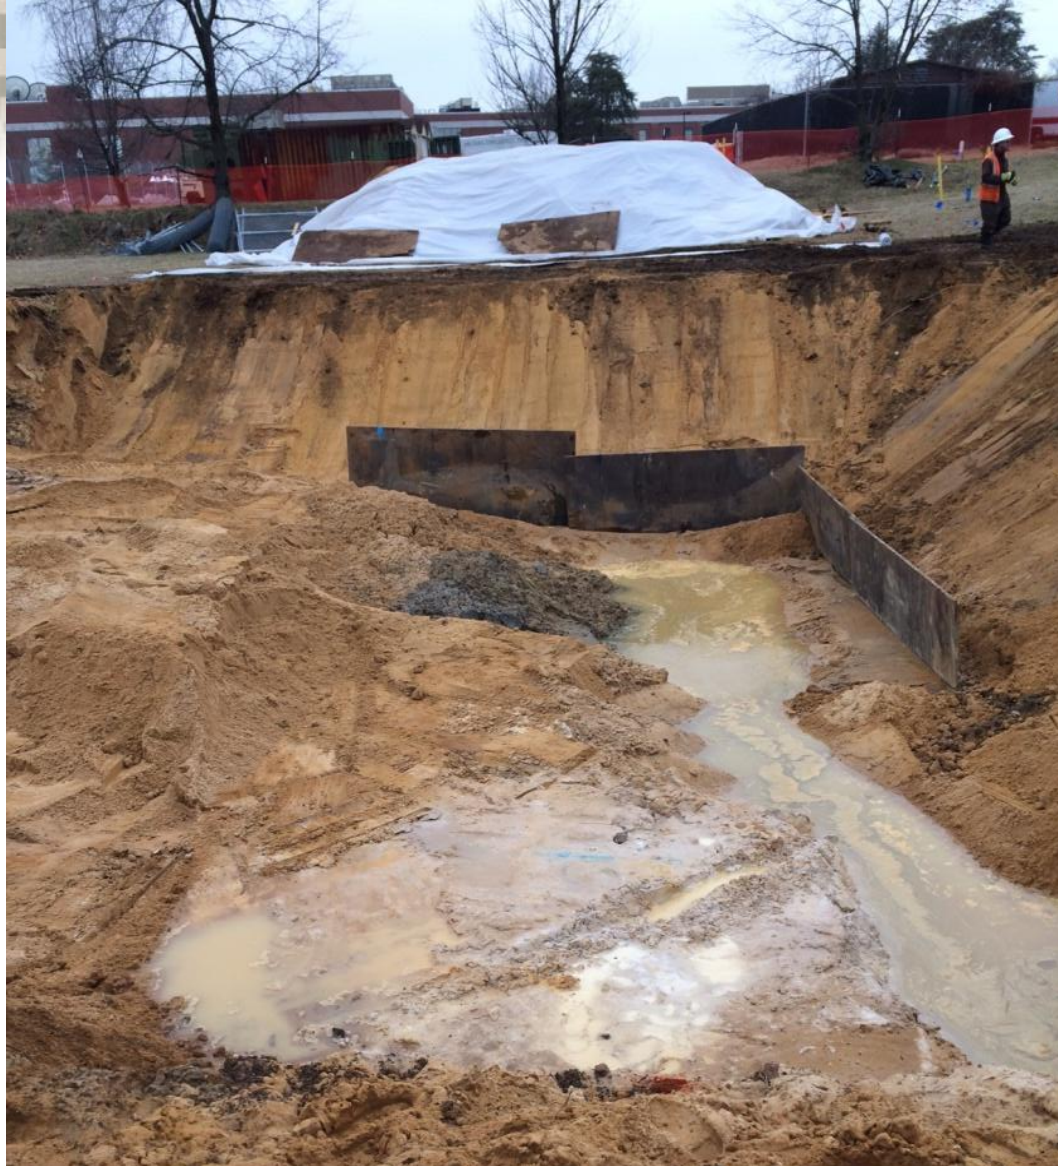
(Facing West) Perched Groundwater Accumulation

- Trucking issues
- Cold weather
- Dewatering
